PROPERTY INSPECTION REPORT

*1212 S Maple St.
Inspection Prepared For: John & Joanne Smith
Agent: Celia House - Best Real Estate Company*

*Date of Inspection: 8/20/2020
Year Built: 1998 Size: 2200 finished, 1200 unfinished
Weather: Rain within past 24 hours*

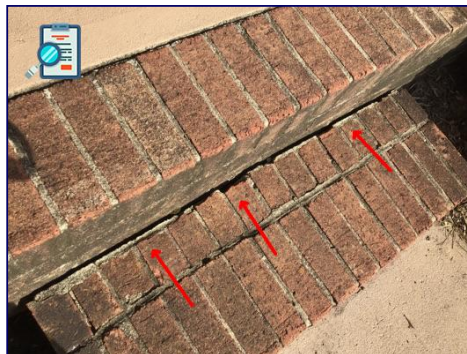
5.2. Steps have settled at the front stoop. Monitor this area, consider repointing mortar joint.

Monitor this area, consider repointing mortar joint.

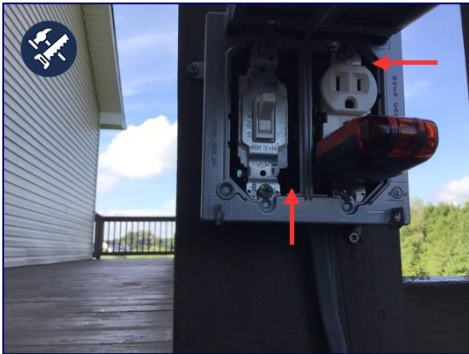
8.3. Missing cover on deck switch & outlet. See pic.

Missing cover plates on switch and outlet.

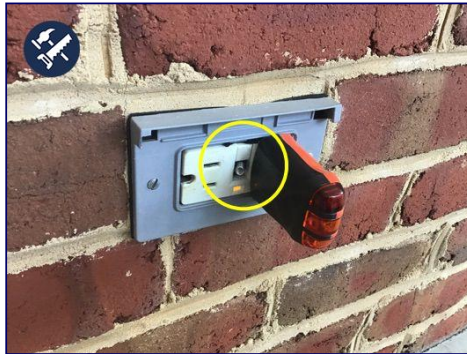
8.4. GFCI in front is damaged or apparently inoperable. Recommend repair/replace by a licensed electrician,

Front GFCI needs repair/replacement

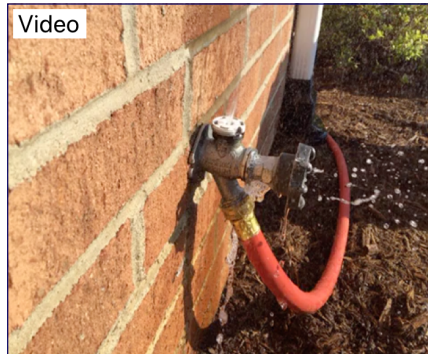
12.1. The front spigot is leaking at valve stem, even when in the open position, recommend repair for water conservation and to prevent possible water damage to structure/water intrusion if the hose is left on for extended period. This is a frost free spigot.

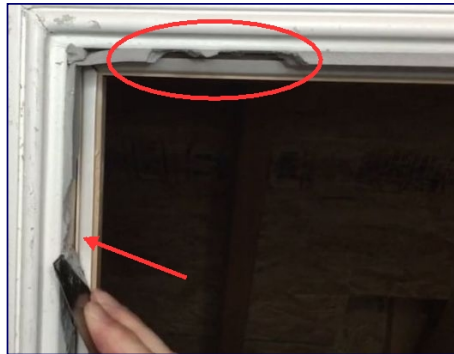
2.2. Insulation worn and torn at back door. Recommend replacing.

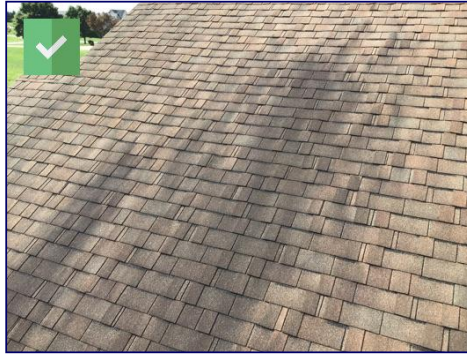
1.2. Clean roof areas: Small amounts of organic debris evident, north facing area of roof (see pic).

Staining. This area of the roof faces north.

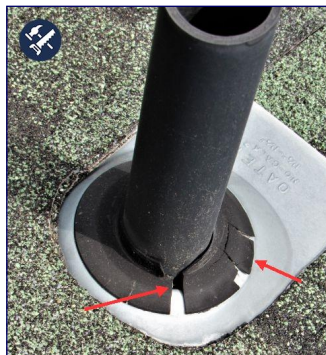
3.1. Vent boot on back side of house is deteriorated and in need of replacement. No evidence in attic of leaks on day of inspection. See picture.

Vent boot back side of house needs replacement

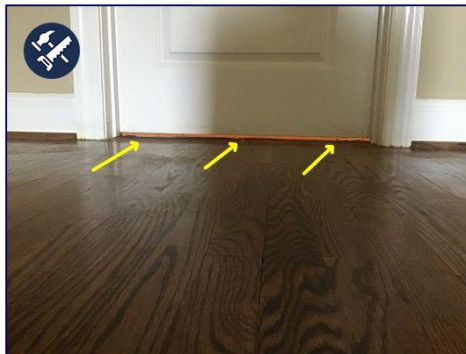
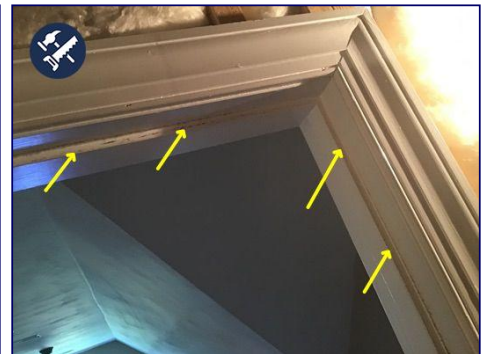
1.3. **IMPROVE:** The attic access doorway is not insulated around door frame. Expect some energy loss through convection. Recommend adding insulating strips around doorway and added door sweep or threshold.

Access door missing insulation

Missing insulation around attic access doorway

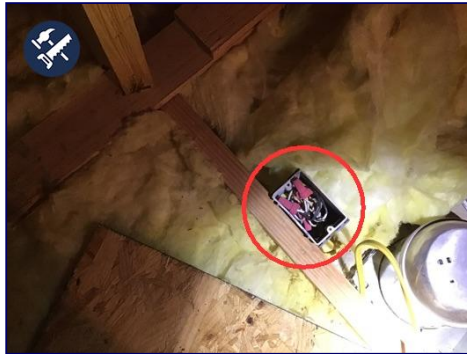
- 4.1. **Electrical Box Covers missing or damaged, which is a potential shock or electrocution hazard.**

Missing covers.

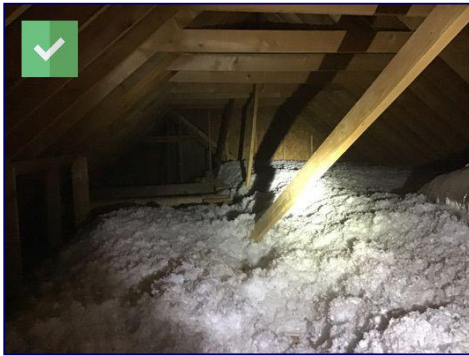
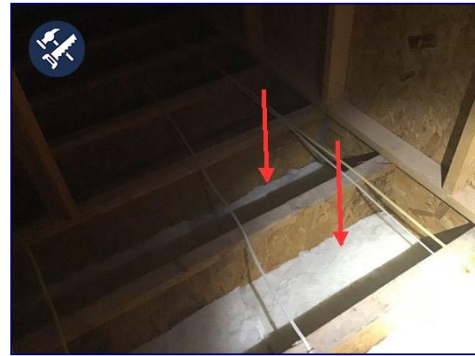
- 6.1. **Insulation is missing in area left of access door. See pic.**

Missing insulation in main attic, left of access door.

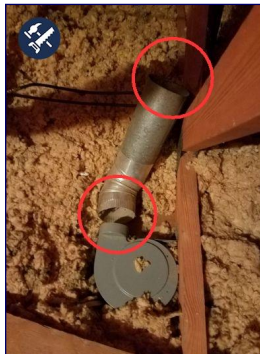
7.1. Exhaust fan duct from master bathroom terminates in attic, which can cause moisture buildup in the attic. Recommend adding duct exhausting to the exterior.

Exhaust vent missing duct from master bath

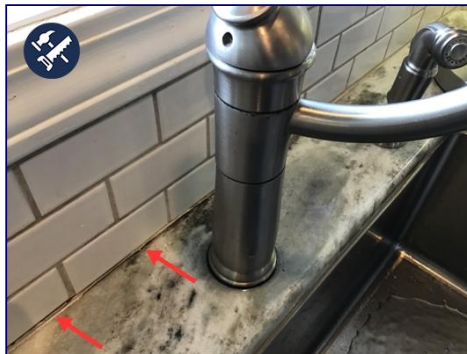
Observations:
6.1. Solid Surface tops noted.
6.2. Recommend sealing with silicone caulk along back splash (see pic). This prevents water leaks from spills and counter cleanups.

Recommend recaulking along back splash

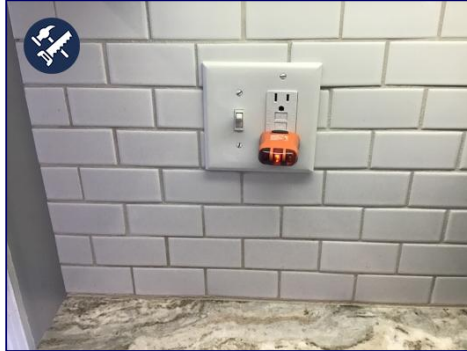
8.2. GFCI left of sink did not respond to test and has open ground. Recommend repair by qualified electrician.

Far left of sink. Open ground, does not trip

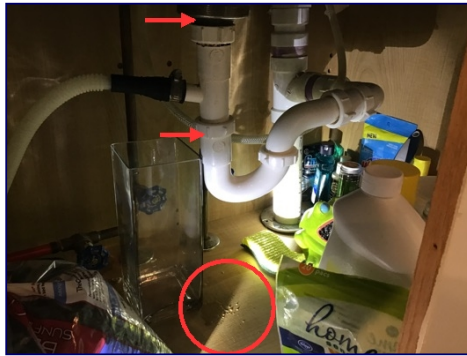
15.1. Visible leaking noted under the sink. Recommend contacting a licensed plumber for repairs.

Leaks from drain tail pipe.

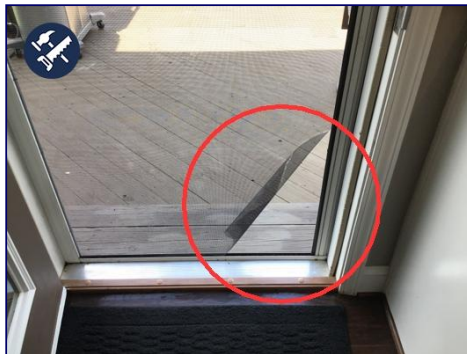
18.2. Sliding door screen is damaged. Recommend repair/replacement screen.

Sliding door screen is damaged.

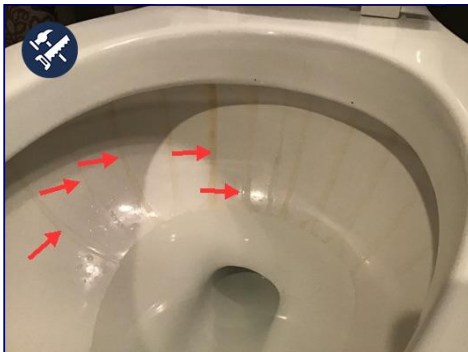
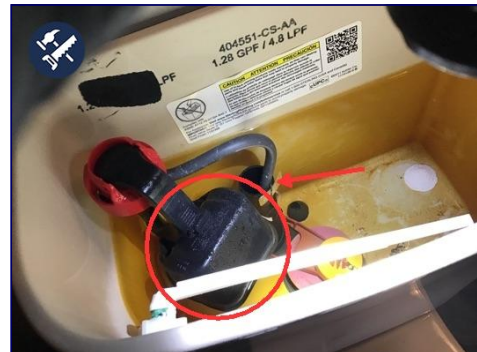
15.2. Float valve in tank requires adjustment for proper flushing. Slow seeping into overflow tube. See pic

Slow seeping into overflow tube, which flows into bowl

Adjust or replace float valve. Arrow indicates overflow tube. Float valve is circled.

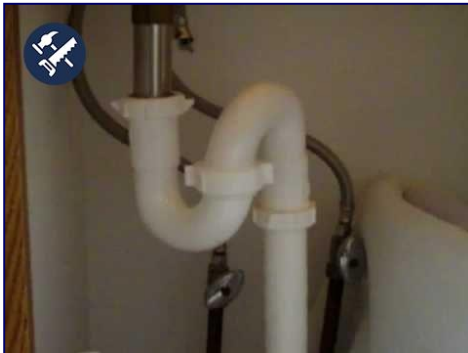
15.1. Improper "S" trap noted. This trap configuration may cause the trap to siphon dry, allowing sewer gas and odour to enter the dwelling. This situation may be rectified by the installation of an anti siphon device (cheater vent). Suggest repair by a qualified professional. In the alternative, run a little bit of water into the sink to reseal the trap if odour is detected. See diagram of S-Trap vs. P-Trap.

Incorrect S-trap

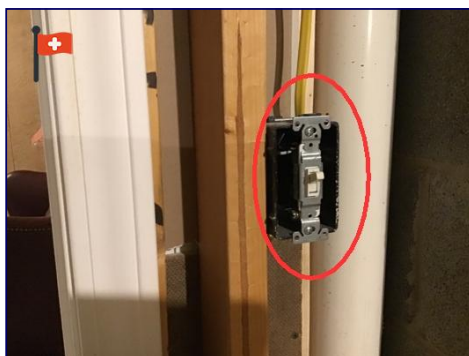
6.1. Switch cover plate missing in unfinished area.

Light switch needs plate.

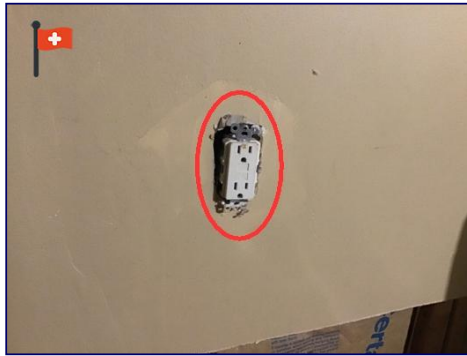
7.1. Smaller storage area in the basement: The GFCI is missing a cover plate, is loose and needs to be secured.

Smaller storage area. Needs fastening and cover

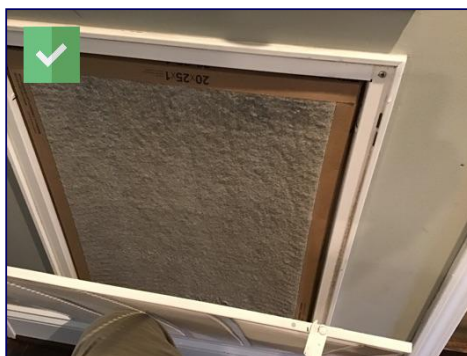
8.2. Return air filter is very dirty. Install new 20" X 25" X 1" filter.

20 x 25 x 1.

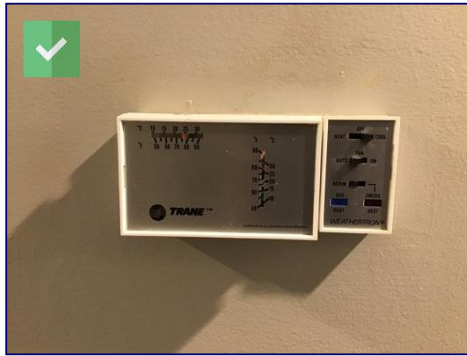
9.5. IMPROVE: Non-programmable thermostats have no energy saving capabilities as do digital setback-type thermostats. Recommend an upgrade to a modern, digital programmable thermostat. This could yield a saving of up to \$180 per year in energy costs.

Recommend upgrade to digital programmable thermostat.

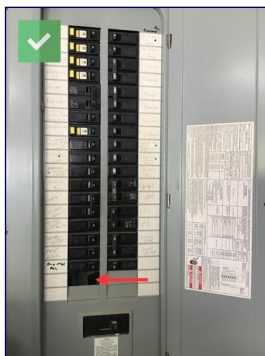
1.2. Open breaker panel slot(s) at panel box cover. Electrocution hazard, access point for vermin.

Open slot; requires filler plate cover.

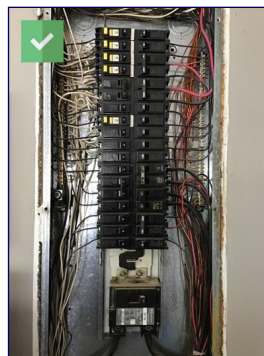
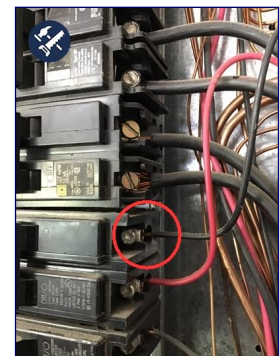
1.3. Undersized 14 gauge wire connected to a 20 amp breaker. Replace wire with 12 gauge, or breaker with 15 amp. Recommend licensed electrician evaluate.

Incorrect gauge wire connection

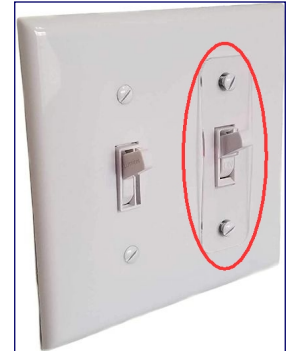
1.2. Recommend adding a switch lock on the radon fan switch.

Light switch lock
